Bulletin

Geological Survey (U.S.)

DEPARTMENT OF THE INTERIOR UNITED STATES GEOLOGICAL SURVEY

EARTHQUAKE EFFECTS ALONG THE FAULT TRACE.

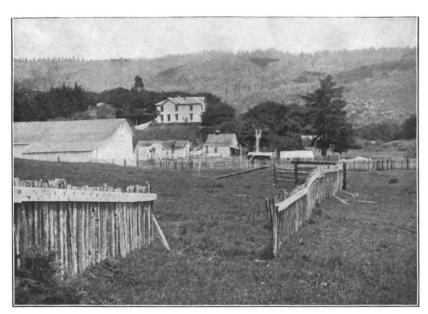
A. ROAD CROSSING FAULT TRACE NEAR POINT REYES STATION.
Looking southwest. Offset, 20 feet. Photograph by G. K. Gilbert.

B. FENCE PARTED BY EARTHQUAKE FAULT.

The fault trace or fracture accompanying the earthquake is inconspicuous, although the horizontal displacement is considerable. Photograph by G. K. Gilbert.

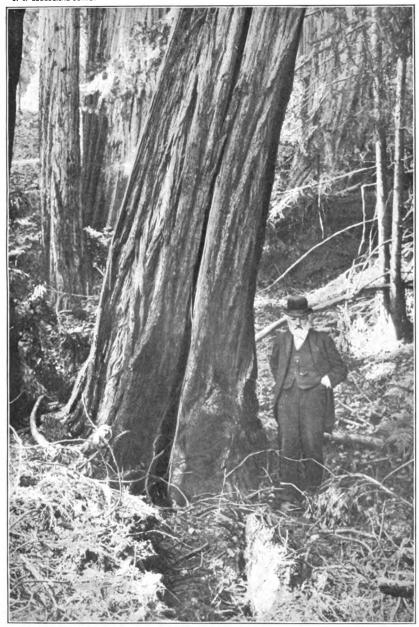
U. 8. GEOLOGICAL SURVEY BULLETIN NO. 824 PL. II

REDWOOD TREE 6 FEET IN DIAMETER ON LINE OF FAULT SOUTH OF FORT ROSS.

The tree was split to a height of 35 feet, although the horizontal displacement was slight. The opening is wedge-shaped at the base, running from a width of 8 inches on the side shown to a fine crack on the farther side. Photograph by Richard L. Humphrey.

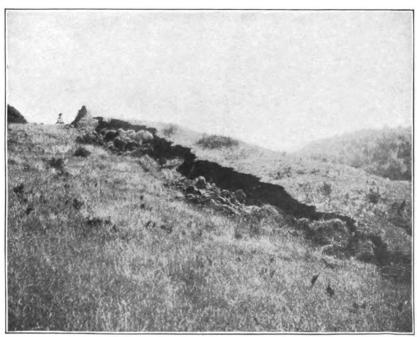
U. 8. GEOLOCICAL SURVEY BULLETIN NO. 324 PL. III

THE FAULT TRACE NEAR POINT REYES STATION.

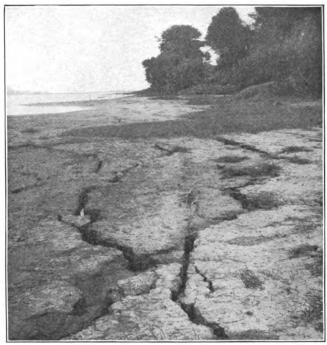
U. 8. GEOLOGICAL SURVEY BULLETIN NO. 324 PL. IV

A. SECONDARY CRACKS, SHORE OF BOLINAS LAGOON.

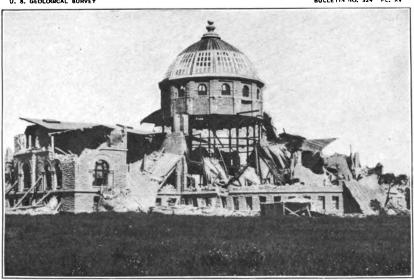
4. COMPARATIVE BEHAVIOR OF REENFORCED CONCRETE AND BRICKWORK UNDER EARTHQUAKE VIBRATION, MUSEUM, LELAND STANFORD JUNIOR UNIVERSITY.

The central portion, of reenforced concrete, was undamaged, but the brick wings collapsed. Photograph by Richard L. Humphrey.

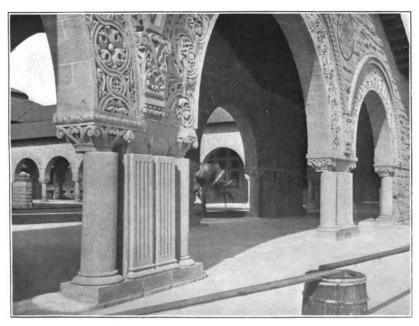
41. EARTHQUAKE DAMAGE DUE TO LACK OF TIE AND BRACING, GEOLOGICAL DEPARTMENT, LELAND STANFORD JUNIOR UNIVERSITY.

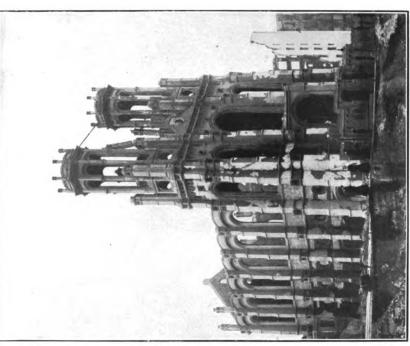
.1. RACKING OF NEWLY CONSTRUCTED BUILDING, SYNAGOGUE: GEARY AND FILLMORE STREETS, SAN FRANCISCO.

Note the separation of the binck veneer from the backing; also the racking of the wall at the corner. Photograph by John Stephen Sewell.

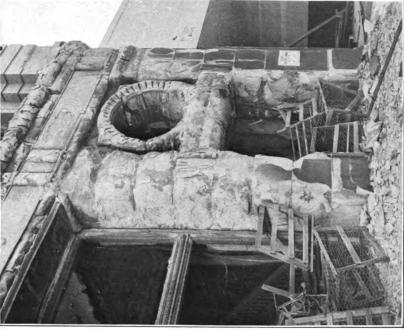
.1. FAILURE OF CAST-IRON SHELL OF CONCRETE-FILLED CAST-IRON COLUMN BY FIRE, ACADEMY OF SCIENCES BUILDING, SAN FRANCISCO. The concrete core supports the load. Note also the effect of the earlieuske on the brick wall in the real. Photograph by Richard L Humphrey.

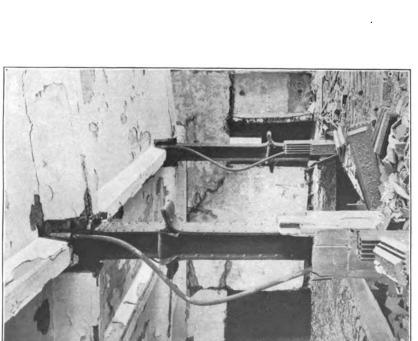
1. FIRE ENDURANCE OF CONCRETE, ANNEX OF ACADEMY OF SCIENCES BUILDING, SAN FRANCISCO.

Reenforced-concrete floors and concrete-filled cast-iron columns with plaster covering. Photograph by Richard L. Humphrey.

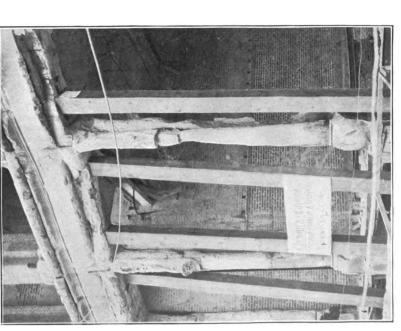
$\it B.$  FAILURE OF SUSPENDED CEILING, HALL OF JUSTICE, SAN FRANCISCO. Photograph by Richard L. Humphrey.

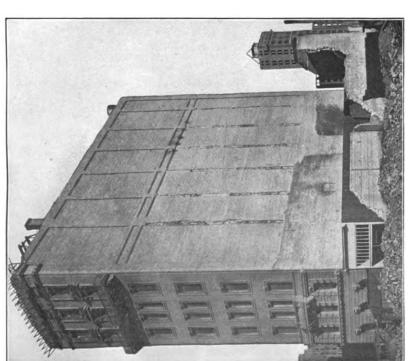
B. BUCKLING OF BASEMENT COLUMN DUE TO FAILURE OF TERRA.
COTTA COVERING IN FIRE, MILLS BUILDING, SAN FRANCISCO.
Photograph by Richard L. Humphrey.

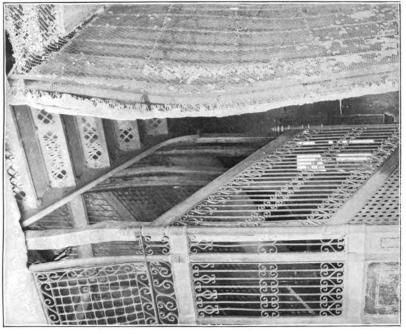
A. ENDURANCE OF A WELL-PROTECTED BUILDING SUBJECTED TO SEVERE HEAT, MAIN EXCHANGE OF PACIFIC STATES TELEPHONE AND TELEGRAPH COMPANY, SAN FRANCISCO.

Rolling shutters self-supporting brick walls, concrete floors, and concrete protection for columns and griders. Photograph by Richard L. Humphrey.

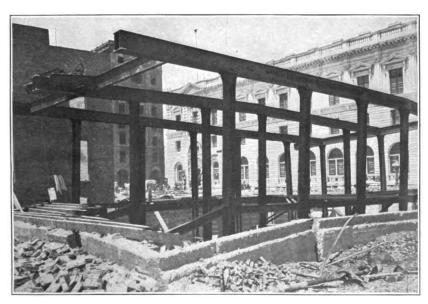
A. ROOF TRUSSES DAMAGED BY HEAT, THROUGH FAILURE OF TERRA-COTTA COVERING, MUTUAL LIFE BUILDING, SAN FRANCISCO.

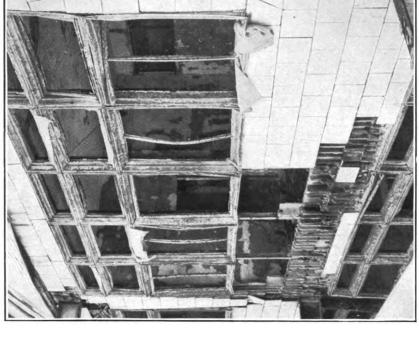
B. DAMAGE SAID TO HAVE BEEN CAUSED BY DYNAMITE, RIALTO BUILDING. Photograph by John Stephen Sewell.

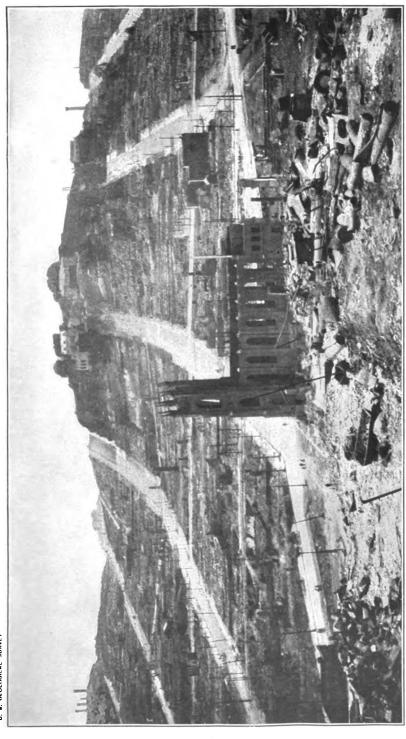
B. GENERAL EARTHQUAKE EFFECT ON FRAME BUILDINGS SITUATED ON ALLUVIAL SOIL, HOWARD STREET, SAN FRANCISCO.
